**PHASE I ENVIRONMENTAL ASSESSMENT
REPORT**

**1395 EAST WASHINGTON STREET (APN 0276-361-21)
COLTON, CA 92324**

PROJECT NO. 224415

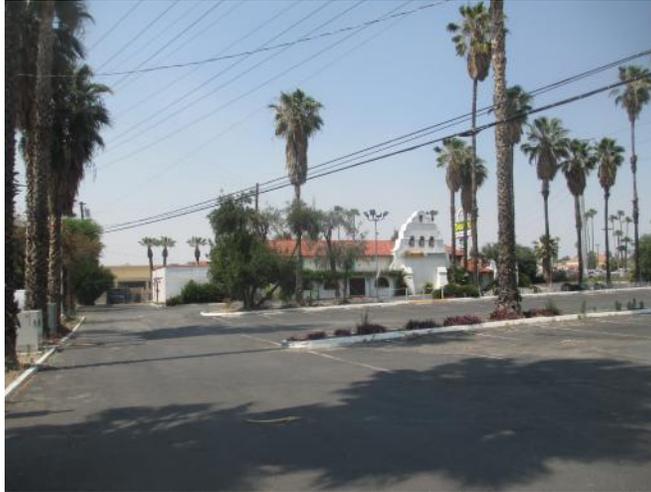
Photo 1

Viewing the site from near its southwestern corner (facing north-northeast)

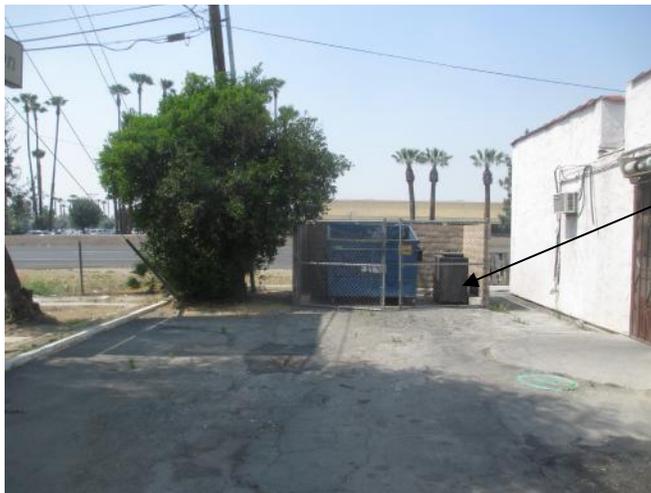
Photo 2

During the site inspection, there was an aboveground used food oil & grease container, along with trash bin, placed within south-facing trash bin enclosure at the northwestern corner of the site. No apparently significant surface staining was noticed around this aboveground used food oil & grease container.

An aboveground used food oil & grease container (indicated by arrow), along with trash bin, placed within south-facing trash bin enclosure at the northwestern corner of the site (facing north-northwest)

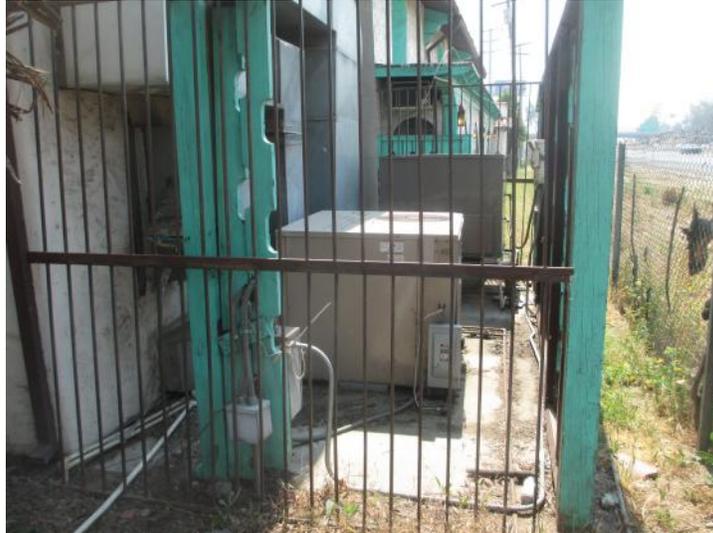
Photo 3

HVAC unit compound (in the forefront) and unpaved ground along the northwest side of the site building (facing southwest)
